# Structural Assessment for Deteriorated Old Building Located in Bethlehem City, Palestine

Nafeth NaserAldeen

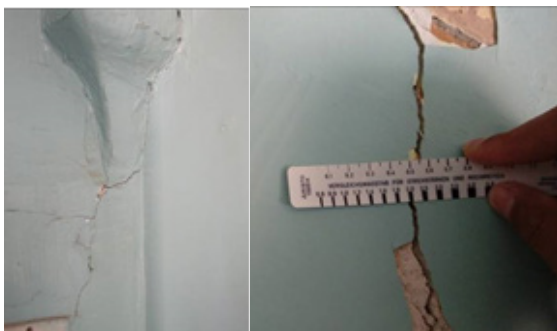
Figure 2. Cracks appeared in the internal plastering la

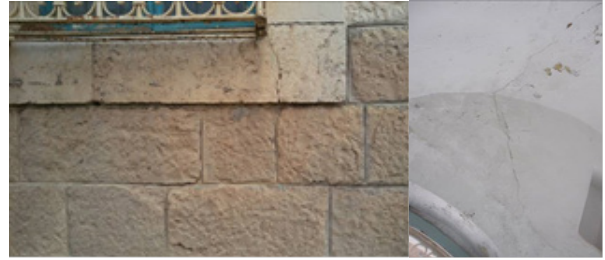
Figure 3. Cracks appeared in the arched opens and in the sill stone at western window open

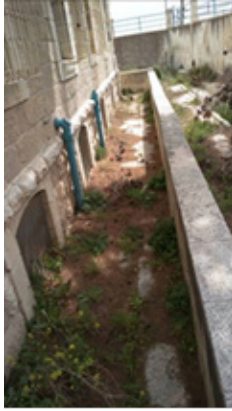
**Figure 4.** Ground surface condition at the west side

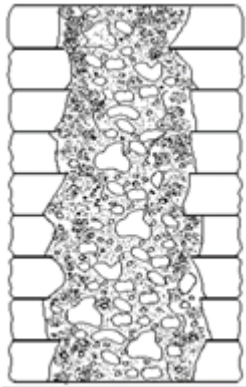
**Figure 5.** Cross-Section for the stone-bearing wall

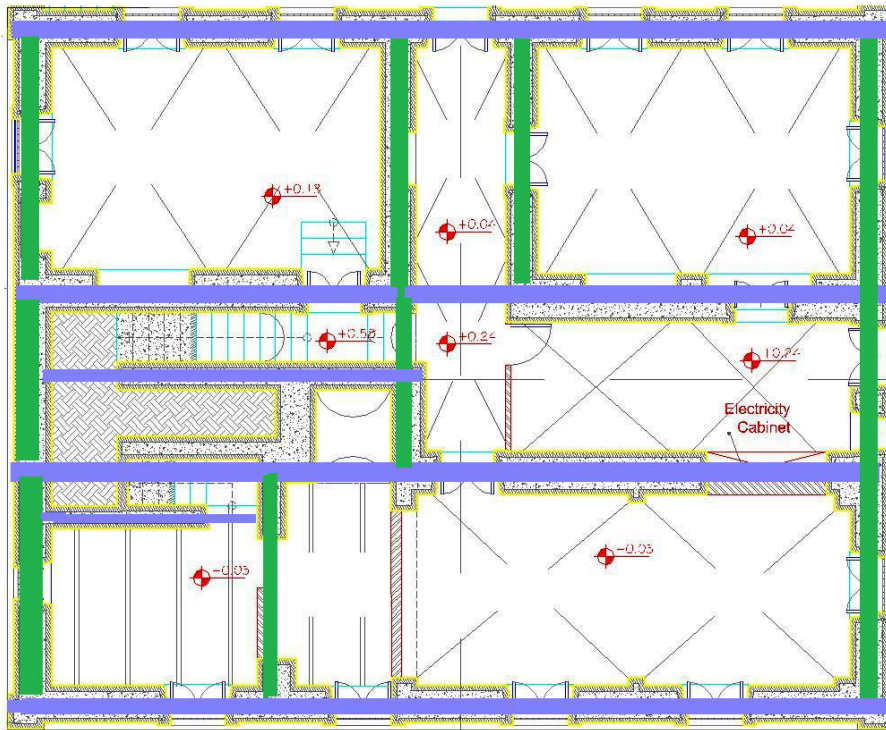
Figure 6. Load carrying structural walls (blue in x direction, green in y-direction)
