A FEM-based model to study the behaviour of corroded RC beams shear-repaired by NSM CFRP rods technique

PhD candidate
Belal ALMASSRI ⁽¹⁾

(1) University of Toulouse; UPS, INSA, LMDC, Toulouse, France

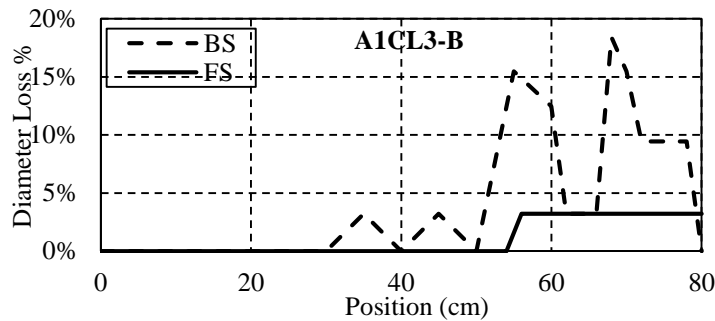
- ➔ The maximum diameter loss found in the tensile steel bars of beam A1CL3-B was 18% while. for A1CL3-SB, it was 9%.

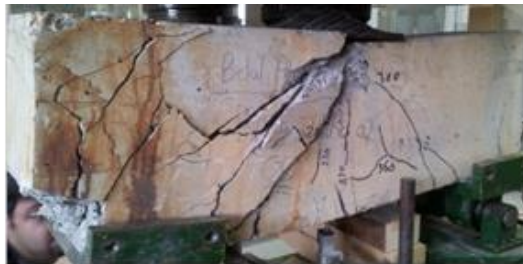
a. A1CL3-B

Diagonal tension failure (Shear cracking failure with slipping of tensile steel bars)

- ➔ Diagonal crack failure Vs failure by a large flexural crack at mid span followed by concrete crushing.

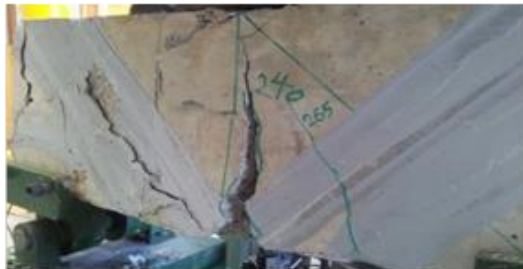
c. A1CL3-SB

Compression crushing of the concrete (Large flexural crack in the middle of the beam)

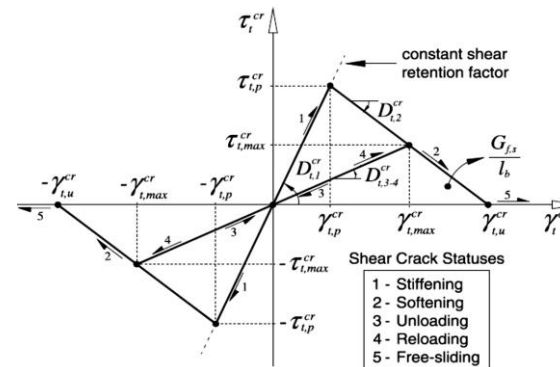
- ➔ Fracture mode I : “a tri-linear tension softening or stiffening diagram”.
- ➔ Fracture mode II: “shear softening of concrete”.

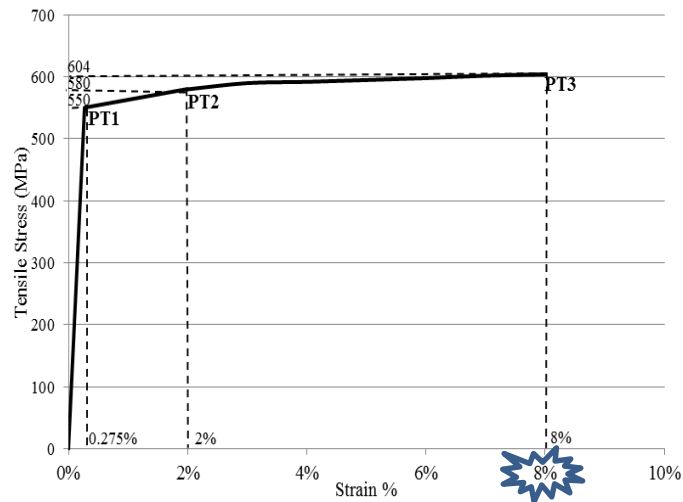
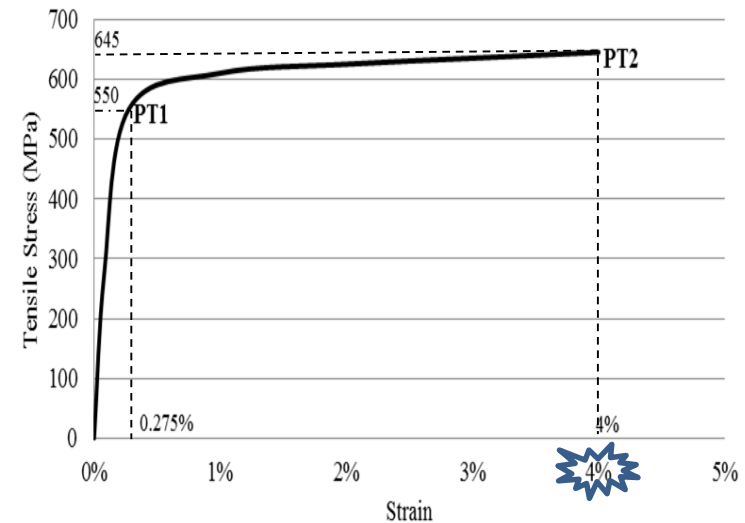
- ➔ The steel reinforcement bars were implemented in this model as elastic-plastic behaviour.
- ➔ Decreased ultimate elongation for the corroded steel bars and stirrups.

- To model the NSM CFRP rods, a linear elastic stress–strain relationship was implemented.

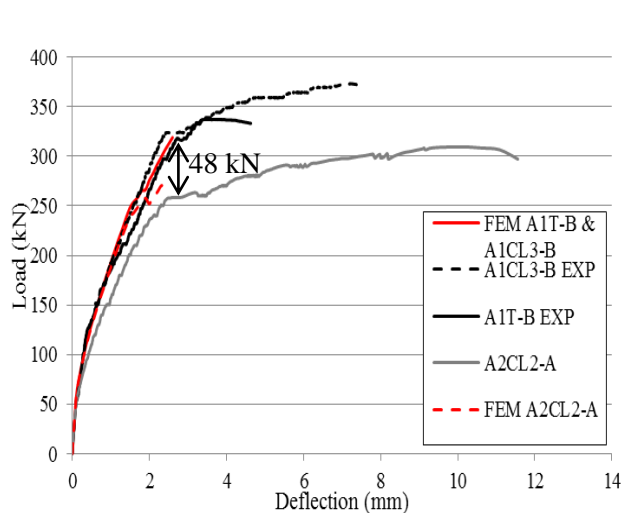
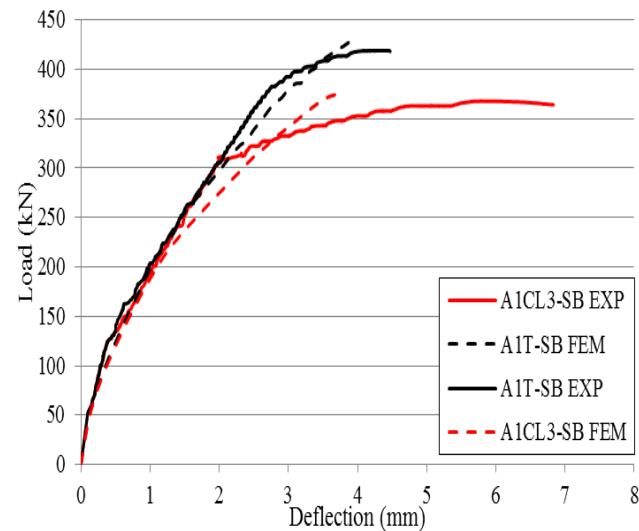
- ➔ 10% loss of tensile steel bar cross section and 77% of diameter loss were used.
- ➔ 12% of loss of cross section led to 12% loss in yielding capacity for SB beams.

- ➔ The steel corrosion did not lead to brittle failure of the steel bars.

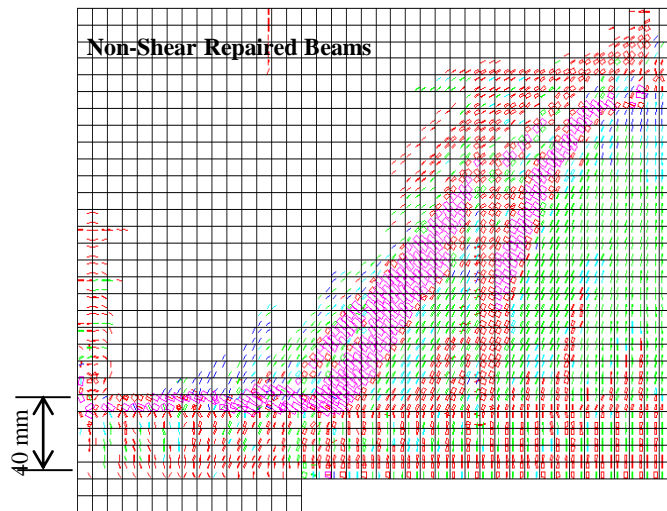
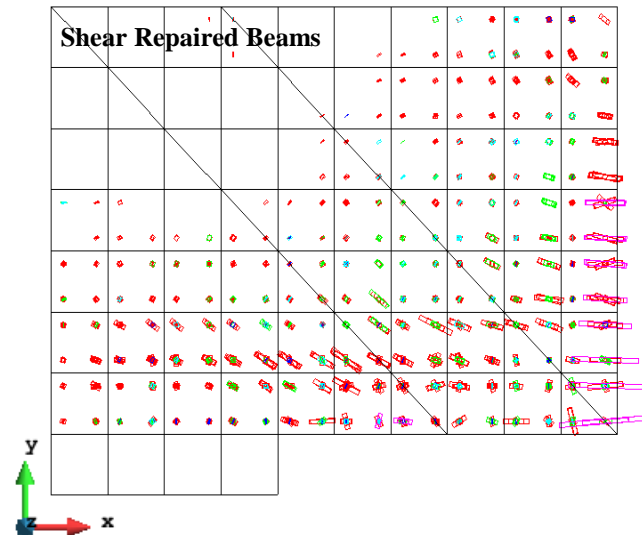
- ➔ Diagonal tension failure with large shear cracks for non-shear-repaired beams.
- ➔ Large Flexural cracks followed by concrete crushing for shear-repaired beams.
