Car Accident Reconstruction

Submitted to the College of Engineering
in partial fulfillment of the requirements for the degree of
Bachelor degree in Automotive Engineering

Palestine Polytechnic University

Dec 2015

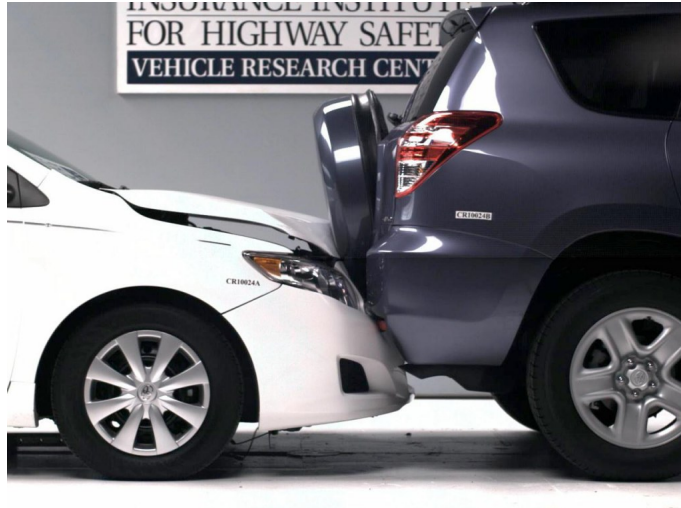
Figure 2.1: Rear-end collision

- 1) **Rear-end collision:** this type of collision happens when one car crashes into a car in front of it. Rear-endings can be caused by sudden deceleration (slowing down or braking) by the first car, or when the following car accelerates more rapidly than the car in front of it, as shown in figure 2.1.

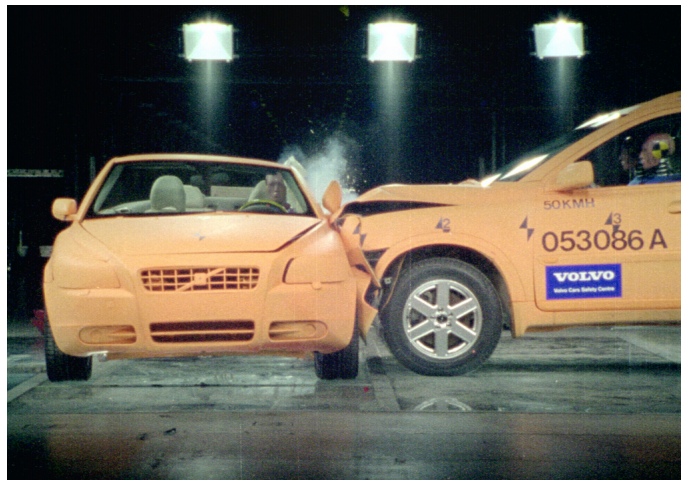
Figure 2.2: Side-impact collision

- 2) **Side-impact collision:** also called a "T-bone" collision, or "broad-sided," this occurs when the side of a car is impacted by the front or rear of another car or a fixed object, as shown in figure 2.2.

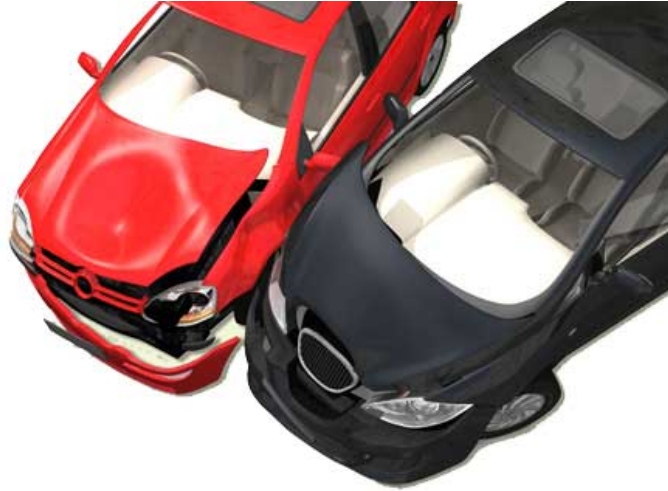
Figure 2.3: Side-swipe collision

- 3) **Side-swipe collision:** this type occurs when the sides of two parallel cars touch and "swipe" each other, as shown in figure 2.3.

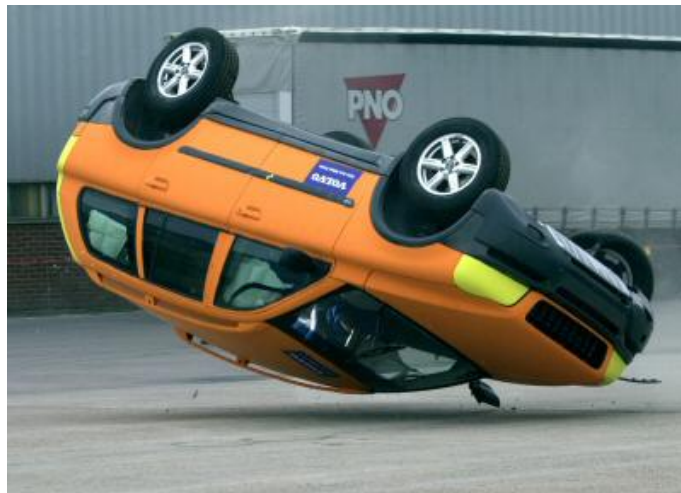
Figure 2.4: Rollover collision

- 4) **Rollover collision:** this occurs when a car flips over onto its side or roof. Rollovers are often caused by a sharp turn at high speed, as shown in figure 2.4. And this is a very dangerous collision.

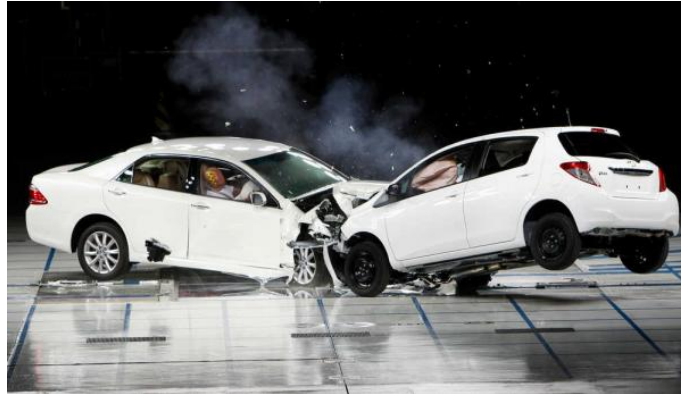
Figure 2.5: Head-on collision

- 5) **Head-on collision:** this occurs when the front ends of two cars hit each other. Head-on collisions are often fatal, as shown in figure 2.5.

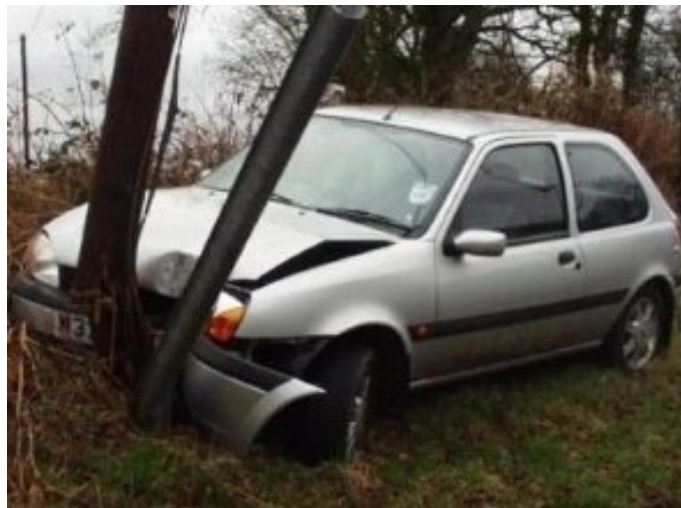
Figure 2.6: Single car collision

- 6) **Single car collision:** this occurs when only one car is involved. In some cases a car strikes other objects such as poles, trees, fire hydrants, walls and may involve innocent pedestrian. Those accidents often result in property damage and personal injury, as shown in figure 2.6.

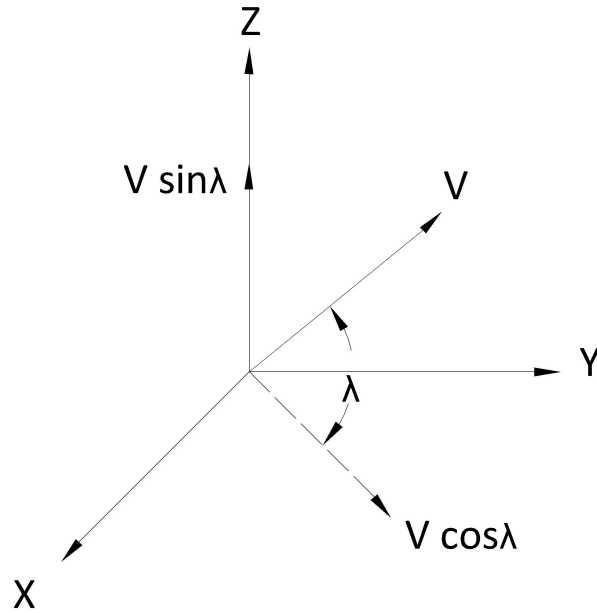
Figure 2.11: Road grade angle

Where $\lambda_1, \lambda_2, \lambda_3$ and λ_4 are the angles between the heading of the vehicles and the road for V_1, V_2, V_3 , and V_4 respectively, as shown in figure 2.11, where the x-y plane is the road plane.

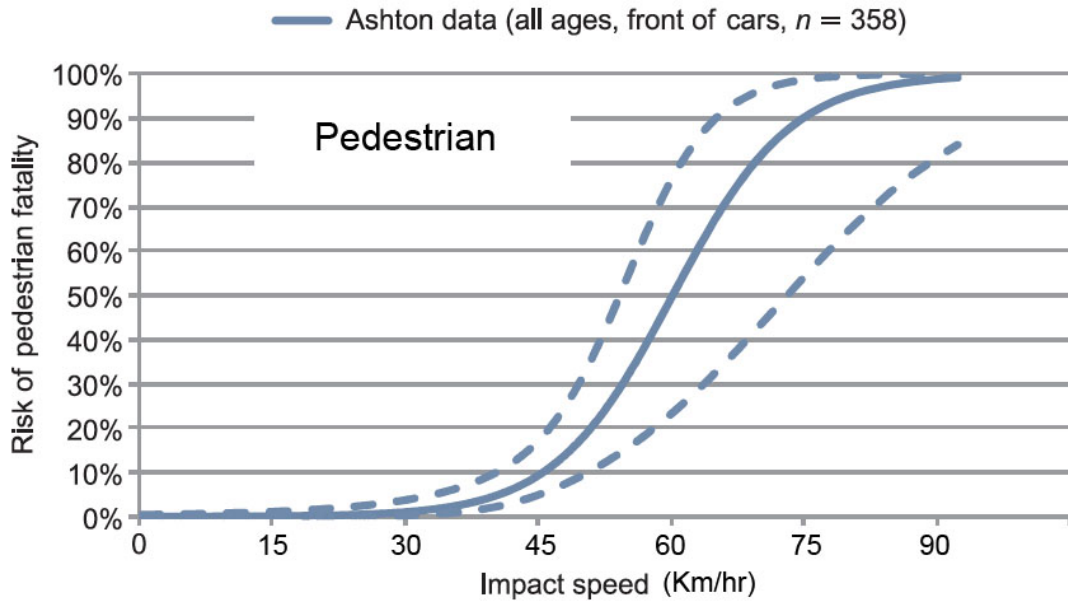
In some cases the investigator couldn't find a logical injury for one of the passengers or the pedestrian, the Department of Transport in London made statistics and studies to estimate relationship between speed and risk of fatal injury. Figure 2.14 shows the relation between impact speed and fatal risk for a pedestrian, and figure 2.15 and 2.16 shows the relation between ΔV and the fatal risk for the driver in frontal impact and side impact with another vehicle respectively.

Figure 2.14: Relation between impact speed and risk of injury for a pedestrian[8]

Figure 2.15: Relation between ΔV and risk of injury for a driver in frontal accident[8]

Figure 2.16: Relation between ΔV and risk of injury for a driver in side accident[8]

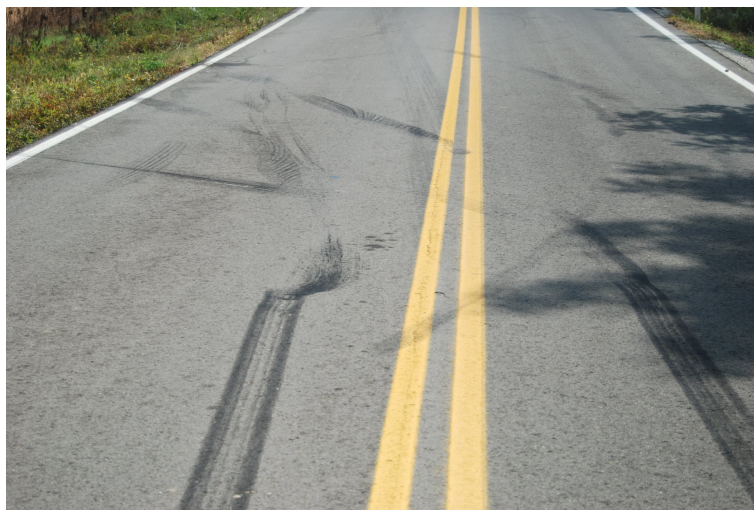
Figure 3.1: Tire marks

In some cases Conservation of Linear Momentum needs additional data from accident site to be solved, so we need additional information to assist linear momentum. One of the information that can be collected from the accident site is the tire marks, which provide us with useful information such as stopping distance. A tire mark is the visible mark left by tires on roads occur when a car wheel stops rolling and slides or spins on the surface of the road, see figure 3.1. Tire marks could happen due to braking only, or due to steering and Yaw striations, or both together, which will be discussed in the present chapter. Tire marks can be analyzed to predict car speed prior to an accident[9].

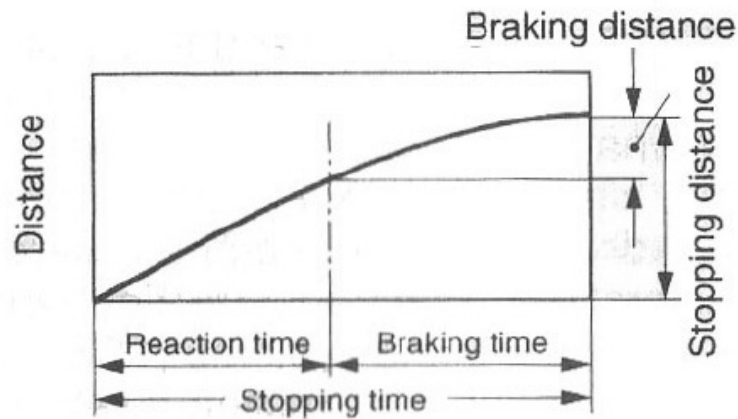
Figure 3.2: Stopping distance

Talking about tire marks and braking leads to a very important terminology, which is the Stopping Distance, it is the distance between the moment when hazard is recognized and the moment when the car comes to a complete stop. In other words, it is the sum of the distance traveled during the reaction time, and the braking time[10]. Where the reaction time is the period between recognizing the hazard and decision to brake, and the time it takes the foot to hit the brake pedal. It ranges between 0.3 to 1.7 seconds depending upon the driver[11]. And braking time defined as the period between pressing on the brake pedal until the car comes to a complete stop[10]. See figure 3.2.

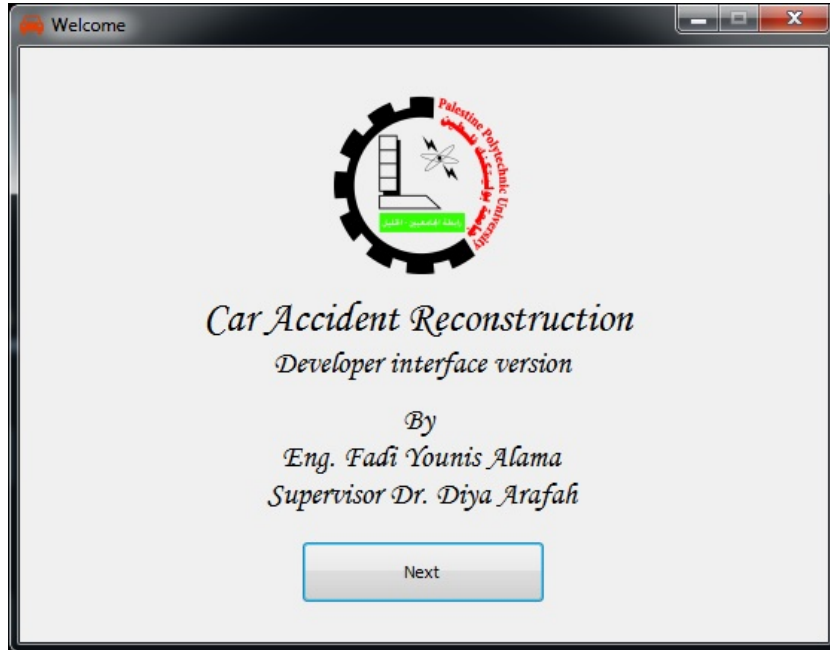
Figure 4.5: Welcome window

At the first a welcome window appear for the user, see figure 4.5.

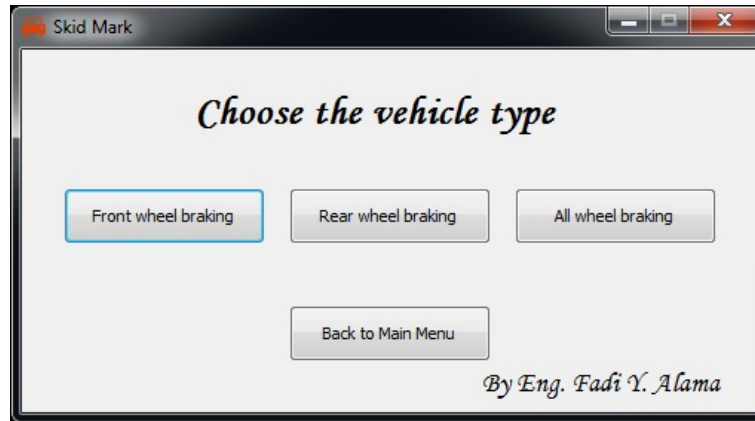
Figure 4.13: Skid mark window

The first additional tool provided in the main menu is the skid marks, this tool ask the user about the vehicle braking type, Front, rear or all wheel braking, as shown in figure 4.13.

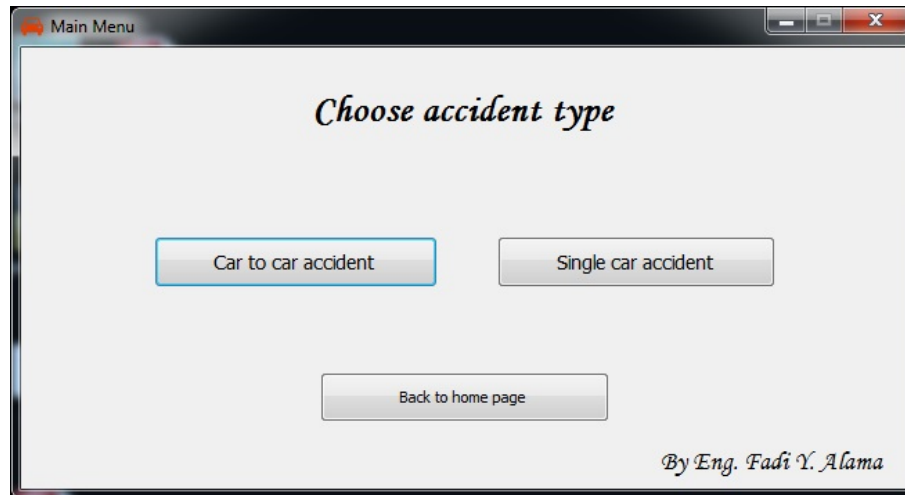
Figure 4.21: Main menu window

In this version the main menu developed to be easier for the user and the program ask the user about the accident type, car to car accident or single car accident, see figure 4.21.

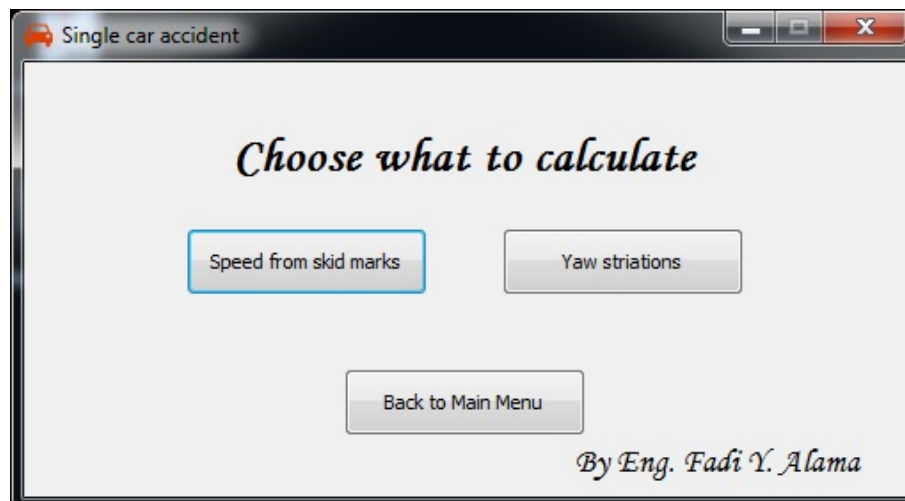
Figure 4.22: Single car accident window

Choosing the car to car accident button will move the user to the combined method directly, and choosing the single car accident will show a new window to choose one of the tools to start, see figure 4.22.

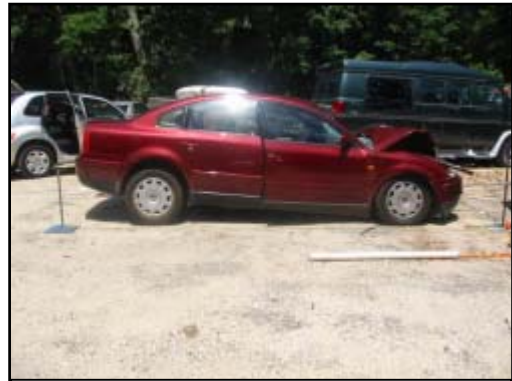
Figure 1. Subject vehicle 1999 Volkswagen Passat.

This remote investigative effort focused on the performance of the Belt Positioning Booster (BPB) seat and the resulting injury mechanisms of the child occupant of a 1999 Volkswagen Passat (**Figure 1**). The Volkswagen was involved in a head-on collision with a 1999 Dodge Ram pickup truck. The Volkswagen was occupied by a restrained 25-year-old female driver and a 3-year-old female positioned in a BPB and restrained by the vehicle's lap and shoulder safety belt in the rear left. The Dodge was occupied by a 39-year-old male driver. The driver of the Dodge initiated a left turn at a Y-intersection which resulted in the head-on collision with the Volkswagen. The impact resulted the frontal air bag deployment in the Passat and the firing of the safety belt pretensioners in the four outboard positions. The 25-year-old female driver of the Volkswagen sustained police reported internal abdominal bleeding and was transported to a trauma center. The medical records for the driver were not obtained due to lack of a medical release and cooperation by the driver. Therefore, the specific injuries and treatment were unknown. The 3-year-old female passenger of the Volkswagen sustained serious level injures and was transported to a local hospital where she was airlifted to a trauma center. The 3-year-old female expired prior to arrival at the trauma center. The driver of the Dodge sustained minor injuries and was transported to a hospital where he was treated and released.

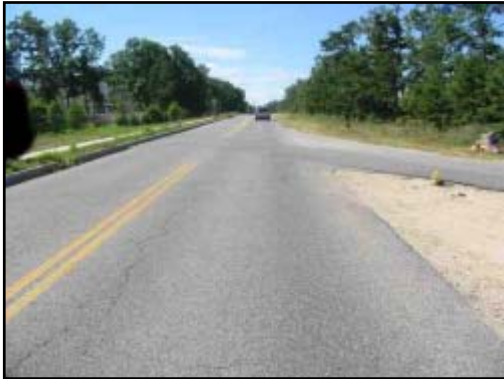
Figure 2. Volkswagen's westbound approach.

The 25-year-old female driver of the Volkswagen was operating the vehicle in a westbound (**Figure 2**) direction on the two-lane roadway approaching a three-leg Y-intersection. The 39-year-old male driver of the Dodge was operating the vehicle eastbound (**Figure 3**) on the same roadway approaching the same intersection. As the driver of the Dodge continued his eastbound travel, he initiated a left turn prior to the intersection and entered the westbound travel lane.

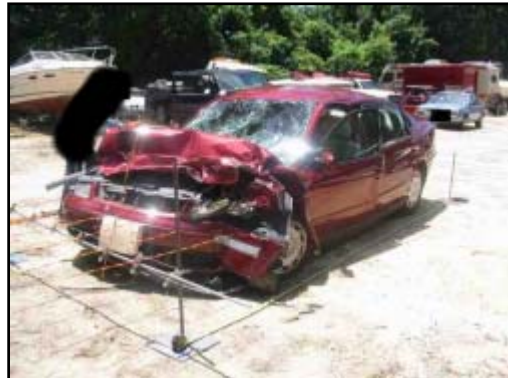
Figure 4. Resultant frontal damage to the Volkswagen.

The 1999 Volkswagen Passat sustained severe severity frontal damage as a result of the impact with the Dodge (**Figure 4**). The direct contact damage began at the front left bumper corner and extended 140.0 cm (55.1”) to the front right bumper corner. The maximum crush was located at the front left bumper corner and measured 68.0 cm (26.8”). The damage resulted in the longitudinal displacement of the frontal components. The NASS researcher used six equidistant measurements to document the crush at the bumper level using a combined direct and induced damage width of 140.0 cm (55.5”) and were as follows: C1 = 68.0 cm (26.8”), C2 = 53.0 cm (20.9”), C3 = 41.0 cm (16.1”), C4 = 30.0 cm (11.8”), C5 = 23.0 cm (9.1”), C6 = 27.0 cm (10.6”). The Collision Deformation Classification (CDC) for this impact was 12-FDEW-3.

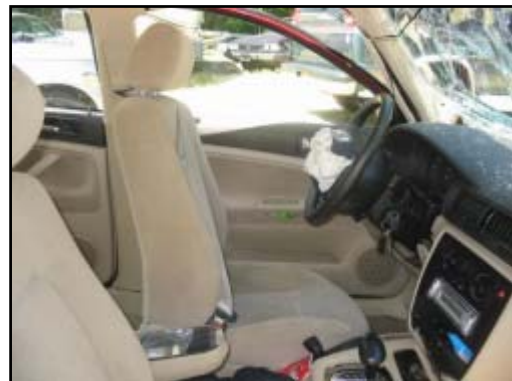
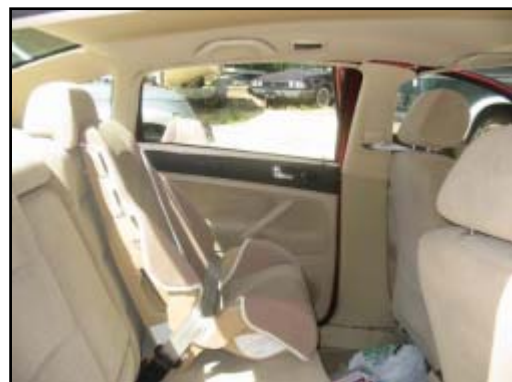
The 1999 Volkswagen Passat sustained moderate damage as a result of occupant contacts. At impact with the Dodge, the frontal air bags deployed. The air bag deployment resulted in the displacement of the driver's left arm. As a result of this displacement, the driver's upper left arm contacted the front left window frame which was evidenced by hair. The driver's lower left arm contacted the door panel mounted power mirror control that was fractured. The NASS researcher noted a scuffmark to the knee bolster from contact with the driver's left knee. Also noted was stretching to the lap belt portion of the safety belt from the driver's abdomen loading the safety belt.

The 3-year-old female rear left passenger was seated in a belt-positioning booster at the time of the crash. At impact with the Dodge, she initiated a forward trajectory and loaded the shoulder portion of the manual 3-point lap and shoulder belt. The NASS researcher noted stretching and scratching to the safety belt webbing from the occupant contact/loading. **Figures 5 and 6** are overall views of the left side first and second rows.

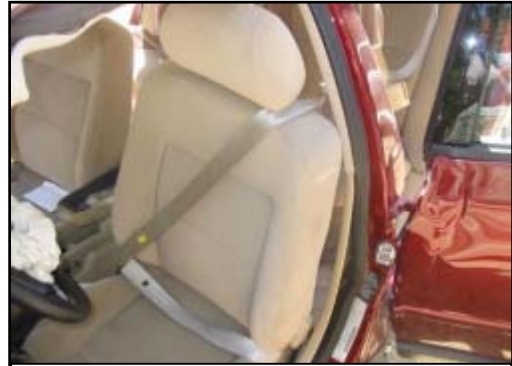
Figure 8. Driver's safety belt.

The 1999 Volkswagen Passat was configured with manual 3-point lap and shoulder belts for the four outboard seating positions. The driver's safety belt (**Figure 8**) was configured with continuous loop webbing, sliding latch plate, height adjustable D-ring that was in the lower position at the time of the NASS inspection, Emergency Locking Retractor (ELR), and a retractor pretensioner that fired as a result of the crash. The stretching to the lap belt portion of the safety belt resulted from the driver's pelvic region loading the safety belt. Minimal occupant contacts and the fired status of the pretensioner supported the safety belt usage for the driver. The front right safety belt was configured with a sliding latch plate, height adjustable D-ring that was in the lower position at the time of the NASS inspection, switchable ELR/Automatic Locking Retractor (ALR), and a retractor pretensioner that did not fire.

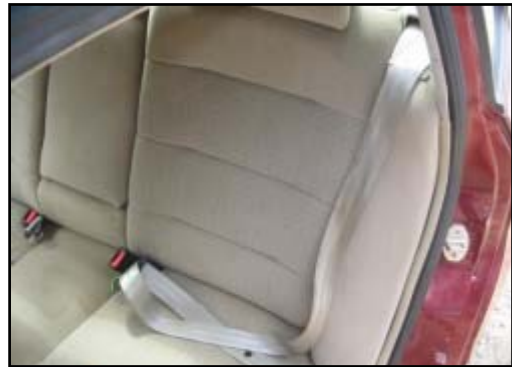
Figure 9. Rear left safety belt with fired pretensioner.

The second row outboard safety belts were configured with sliding latch plates, switchable ELR/Automatic Locking Retractor (ALR), and retractor pretensioners that fired as a result of the crash. The rear left safety belt (**Figure 9**) was used with a high back belt-positioning booster seat which was supported by the stretching and scratching to the safety belt from the occupant contact/loading and fired retractor pretensioner. The rear right safety belt was used to restrain an unoccupied belt positioning booster seat at the time of the crash, which was evidenced by the fired retractor pretensioner. The rear center safety belt was a 2-point manual lap belt that was configured with a sliding latch plate and an ALR.

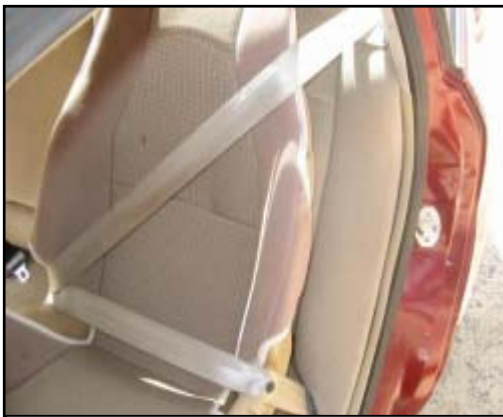
Figure 10. BPB in the vehicle's rear left position.

The Cosco Complete Voyager high-back Belt-Positioning Booster (BPB) seat (**Figures 10 and 11**) was identified by the Model Number: 22-210-TIM. The date of manufacture was March 5, 2004. The BPB was configured with three shoulder belt positioning slots on the upper outboard aspects. It was not known what position the shoulder belt was placed. It should be noted that use of the shoulder belt positioners could not be confirmed. The NASS researcher noted a stress crease on the rear aspect of the right side panel of the of BPB. Also noted was a spot of body fluid on the upper right side of the seatback and a scuff to the lower right side of the cushion. The manual 3-point lap and shoulder belt was used to restrain the child in the rear left seat of the vehicle. The vehicle's safety belt system was equipped with a retractor pretensioner that fired as a result of the crash. The safety belt was found restricted in the used position which was as result of the fired pretensioner. The BPB was used to position the 3-year-old child to ensure a proper

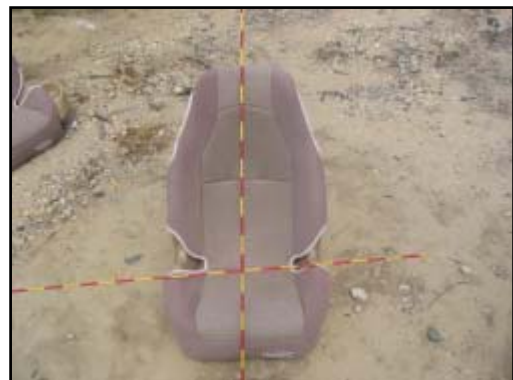
Figure 12. Unoccupied BPB.

The NASS researcher noted a second BPB (**Figure 12**) in the rear right position of the Volkswagen. This BPB was not occupied at the time of the crash. The BPB was a Cosco Complete Voyager with a model number of 22-210-TM. The date of manufacture for this BPB was November 13, 2003. The BPB was found with the manual 3-point lap and shoulder belt in the used position. This was supported by the fired retractor pretensioner.

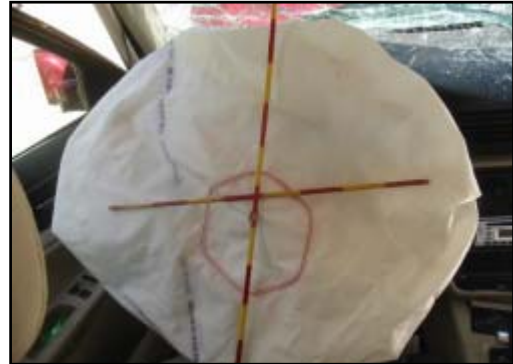
Figure 13. Deployed driver's frontal air bag.

The driver's air bag module consisted of two H-configuration cover flaps. The top cover flap measured 17.0 cm (6.7") in width and 9.0 cm (3.5") in height. The lower cover flap measured 17.0 cm (6.7") in width and 7.0 cm (2.8") in height. The driver's air bag measured 72.0 cm (28.3") in diameter in its deflated state and contained two tethers. A single vent port that was located at the 12 o'clock position on the rear aspect vented the air bag. The NASS researcher noted no occupant contacts or failures to the driver's air bag. **Figure 13** is an overall view of the deployed driver's frontal air bag.

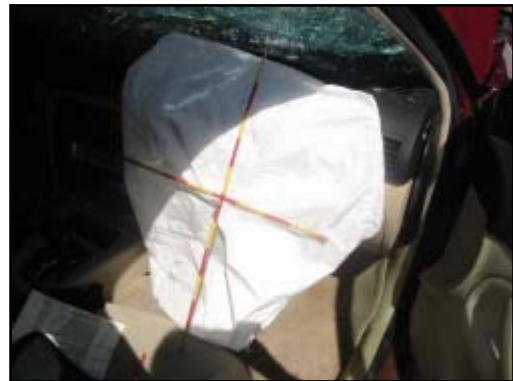
Figure 14. Deployed front right air bag.

The front right air bag (**Figure 14**) module consisted of a single cover flap configuration that measured 34.0 cm (13.4") in width and 20.0 cm (7.9") in height. The air bag membrane measured 70.0 cm (27.8") in width and 85.0 cm (33.5") in height and was not tethered. A single vent port that was located at the 11 o'clock position on the rear aspect of the top panel vented the air bag. No occupant contacts or failures were noted to the front right air bag.
