Conference Paper · June 2014

STUDY ON BEHAVIOUR OF CORRODED RC BEAM STRENGTHENED WITH CFRP ROD, AN EXPERIMENTAL AND FINITE ELEMENT MODELLING STUDY

KEYWORDS: corrosion, repair, RC beams, NSM rods, failure mode, FEM, ABAQUS.

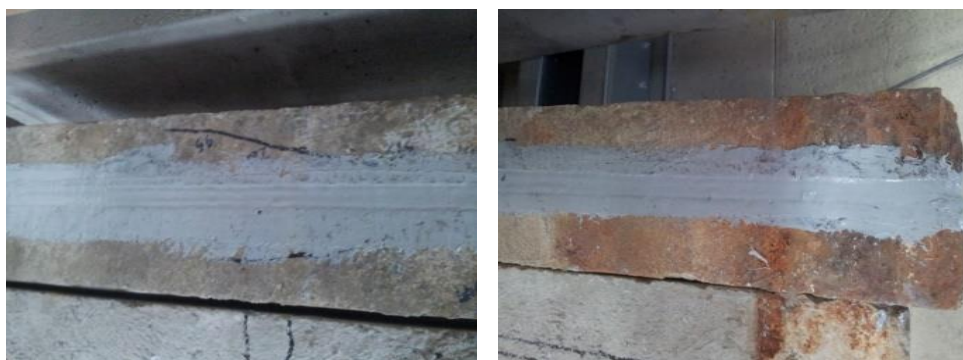
a. A1T Control.Beam

b. A1CL3 Corroded. Beam

Fig. 3. Concrete surface after installing the CFRP rod.

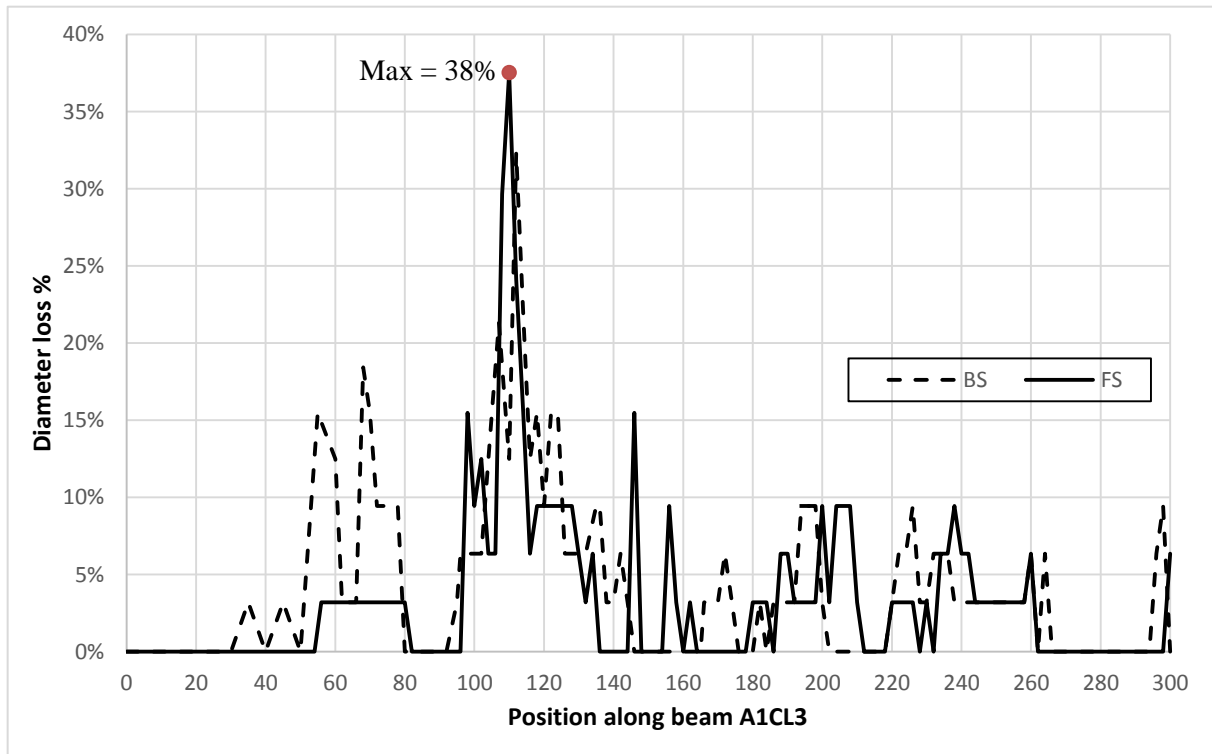
Fig. 4 Diameter loss percentage in corroded beam A1CL3-R.

The values of the diameter losses were measured for both the Back Side (BS) and Front Side (FS) tensile steel bars which were extracted from the corroded beam A1CL3-R just after the bending test. The maximum diameter loss was found 38% at 120 cm away of the left edge of the beam. The corrosion was found both at the top of the bars close to the surface cover reflected the classical result for natural corrosion (Yuan et al., 2007) and at the bottom of the bars reflected the effect of casting direction and bar location at the top of the beam known as “Top-bar effect” (Horne et al., 2007; Soylev and François, 2003). Figure 4 shows the diameter loss percentage along the corroded beam A1CL3-R for both tensile bars BS and FS.

The corrosion cracks shown in figure 12 are considered to be the main reason behind getting the separation of concrete cover as a mode of failure for the repaired corroded beam. This plane of cracks was simulated using a crack tool in interaction section in ABAQUS as shown in figure 13. As well as the cross-sectional area of tensile steel bars of corroded beam A1CL3-R are reduced due to the corrosion and they are given an average corrosion value (15% for tensile steel bars) at the middle of the beam as shown in corrosion percentage map in Figure 4.

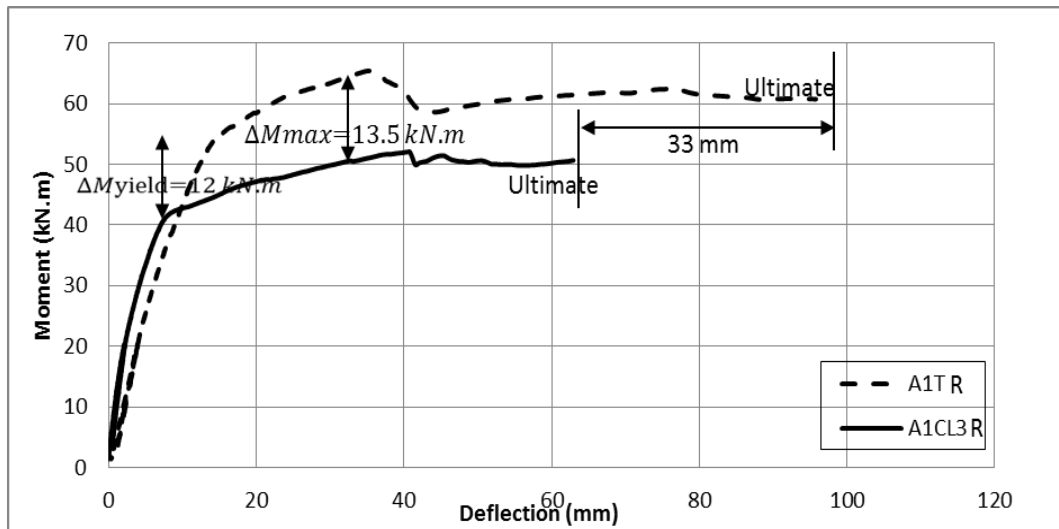
Fig. 7 Bending moment versus deflection

The two repaired beams A1CL3-R and A1T-R were tested with 3-point loading up to failure. Figure 7 shows the bending moment versus the deflection for the two beams. The ultimate moment values were 52 kN.m and 66 kN.m respectively.

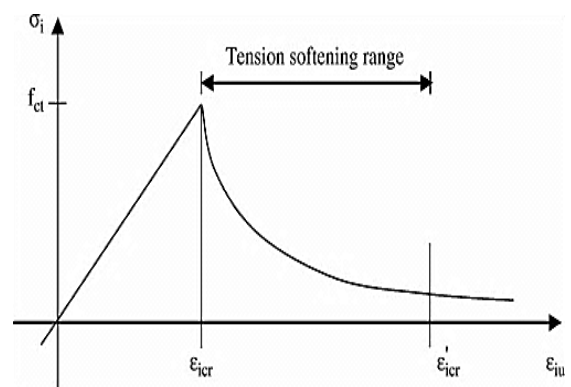
Fig. 10 Tension softening of concrete

The concrete tensile strength values of concrete are less than the compressive values and the concrete failure is brittle in tension, the same modulus of elasticity and Poisson’s ratio are used here using the same tensile strength values obtained by the uniaxial traction tests shown in table 1.

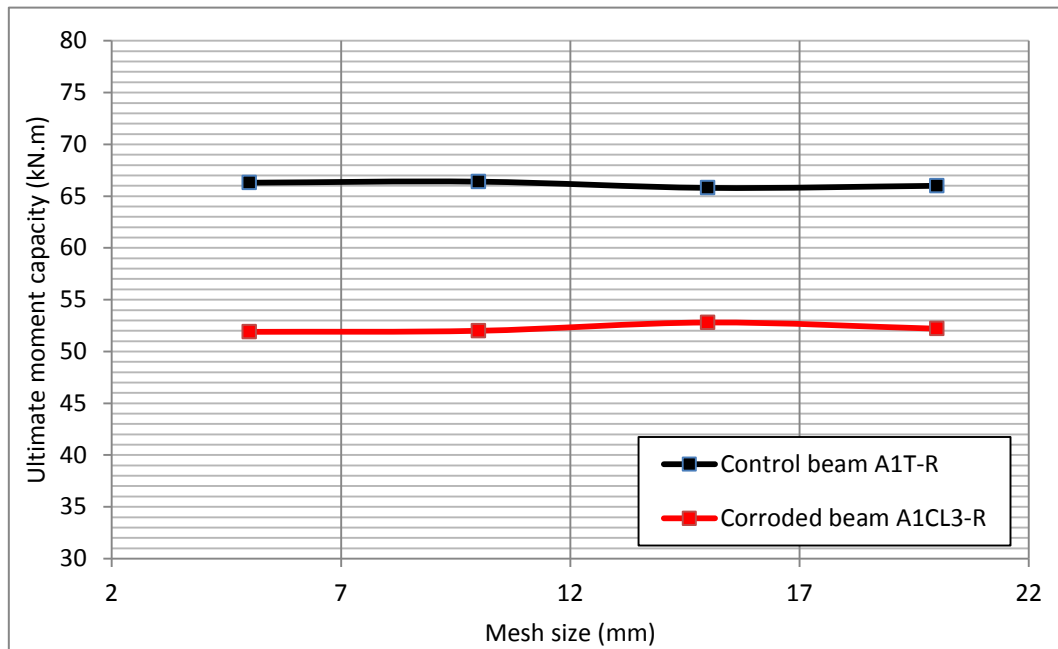
Fig. 16 Mesh size effect

Different mesh sizes are used in this part of analysis (20, 15, 10 and 5mm) in order to study the effect of changing elements sizes during the analysis, figure 16 shows that there was no significant effect on the ultimate moment value for control beam A1T-R and corroded beam A1CL3-R if the mesh size is changed which agrees with what is found by (Radfar et al., 2012).

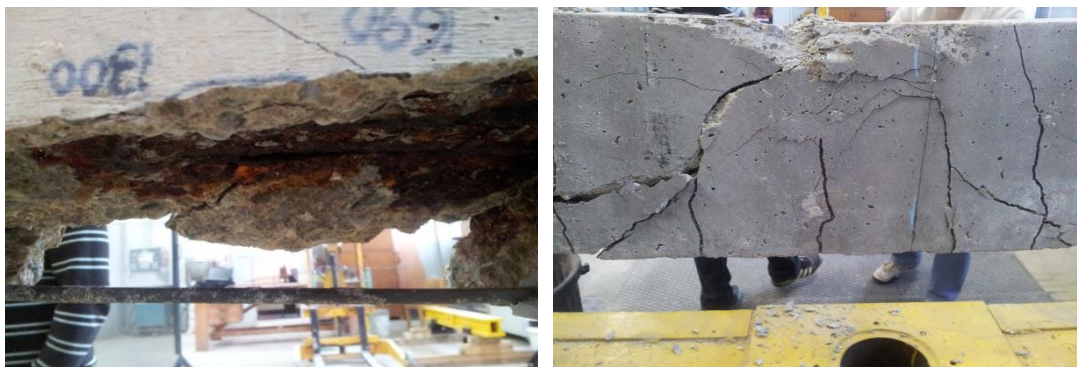
a) A1CL3-R Corroded

a) A1T-R Control Beam

Fig. 17 Experimental Failure modes of both beams

The failure mode of non-repaired type A beams usually happens due to steel bar yielding followed by concrete crushing (Khan et al., 2012). After strengthening with NSM FRP rod, the RC beams may fail by concrete crushing, pull-out of the FRP rods or peeling-off as shown by (Al-Mahmoud et al., 2009), the failure mode of the repaired control beam A1T-R occurred by the crushing of compressed concrete while the failure mode observed for A1CL3-R was different from both the conventional and non-conventional failure modes found on non-corroded repaired beams. The failure mode of the repaired corroded beam A1CL3-R was due to the separation of the concrete cover as shown in Figure 17.
