Study on behaviour of corroded RC beams repaired in shear with NSM CFRP rods

Belal ALMASSRI¹, Amjad KREIT¹, Firas AL MAHMOUD², Raoul FRANCOIS¹

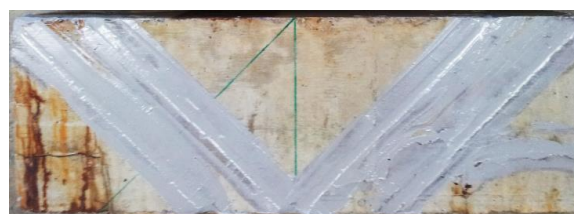
Fig. 6.b A1CL3-SB after repairing in shear.

The two edges (A1CL3-SB and A1T-SB) were re-repaired in bending and in shear using the configuration shown in figure 2. Four rods were installed on each side of each edge spaced with 10cm. The same procedure and technique followed for installing the rods shown in figure 4. Figures 6a, 6b present the two edges (A1T-SB and A1CL3-SB) after the repairing in shear.

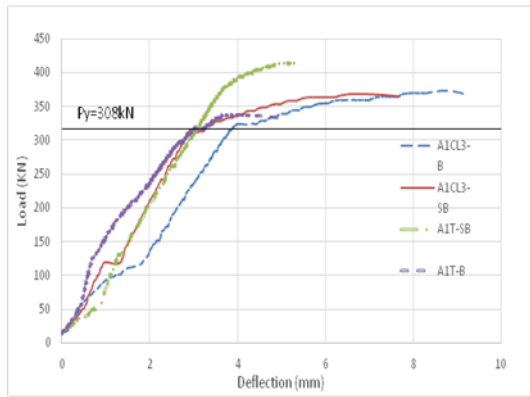
Fig. 11 Load capacity vs deflection for beams.

Figure 11 shows the ultimate load capacity of the four beams versus the deflection values.

The calculated yielding force Py agrees with the experimental results for non-repaired beams in shear A1T-B and A1CL3-B as shown in figure 11.

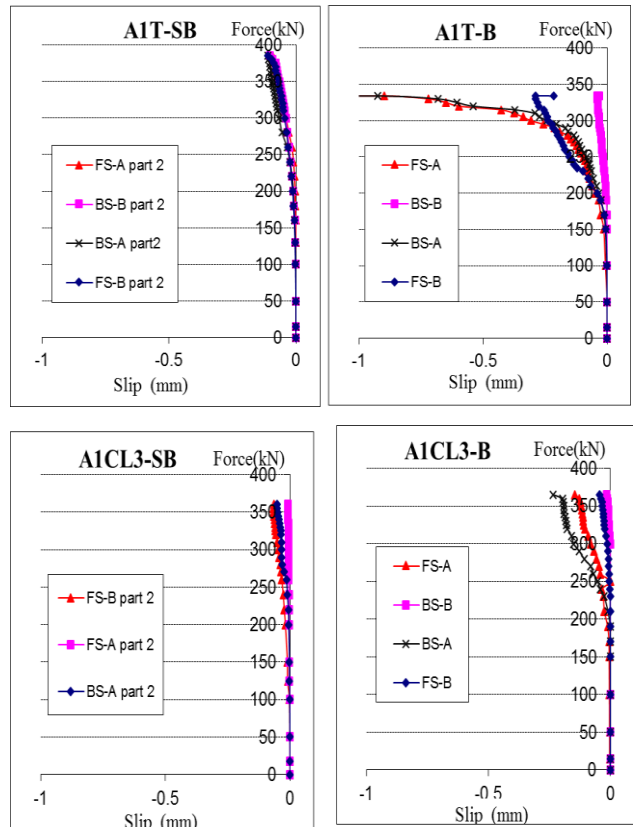
Fig. 14 Slip measurements for four tested beams.

Figure 14 shows the slip measurements for tensile steel bars of the four tested beams.

The slipping of the steel bars in repaired corroded beam in bending only (A1CL3-B) started at 250 kN and 200 kN for the control beam (A1T-B). Beams tested by [13] showed that slipping started at 100 kN and 150 kN. The maximum slip value found in control beam A1T-B was larger than the slip value in corroded beam A1CL3-B (1mm and 0.23 mm respectively) which agrees with [14] that showed an enhancement in the anchorage capacity between steel and concrete in the corroded beams due to the increased radial stresses on the bar-concrete interface of the end points of beams. If the repaired beams in shear A1T-SB and A1CL3-SB are compared to non-repaired beams, it is very clear that repairing in shear with NSM decreased significantly the maximum slip values (from 0.23mm to 0.05mm for A1CL3 and from 0.92 to 0.09).
