Mechanical behaviour of corroded reinforced concrete beams strengthened with NSM FRP technique

Belal Almassri

University of Toulouse

Mechanical behavior of corroded RC beams strengthened with NSM FRP technique

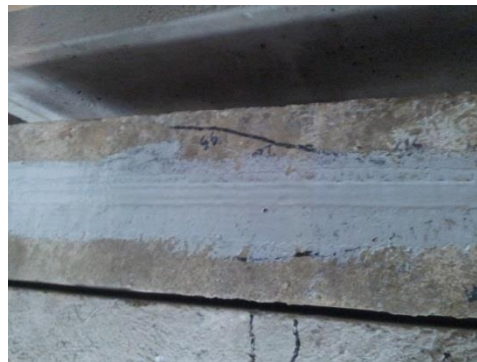
a) A1T -R Control Beam

- ➔ The two beams were tested 1 week after installation of the CFRP rod
- ➔ The groove was 15 mm deep and 15 mm wide (around twice the rod diameter).

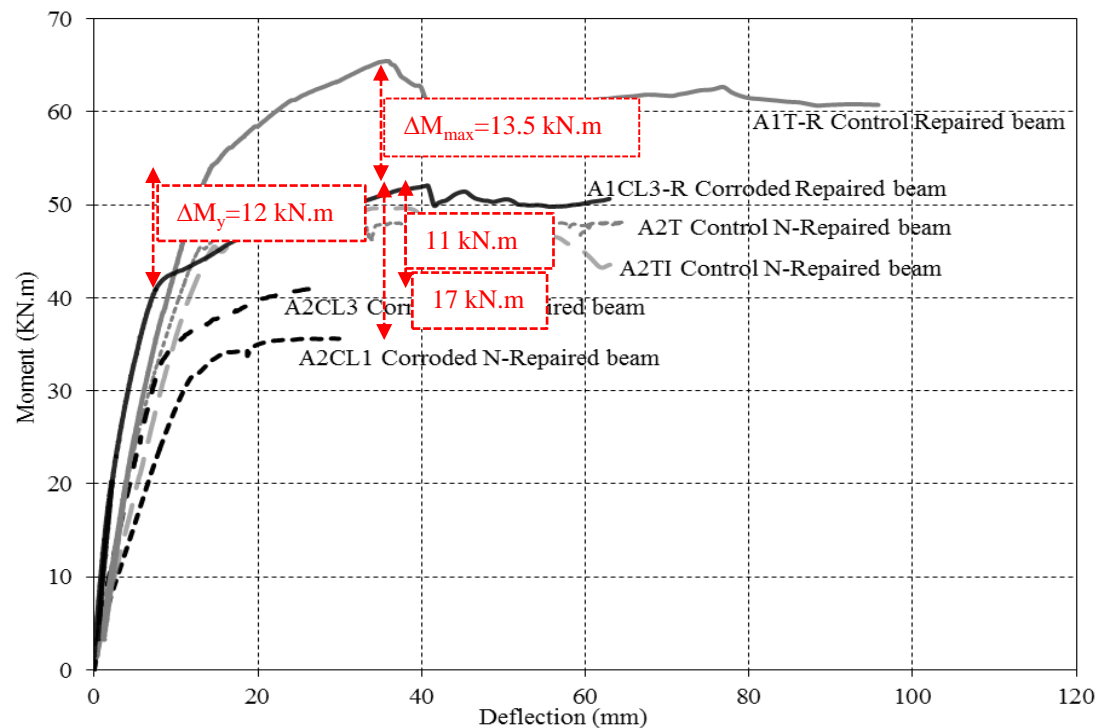
➔ Ultimate moment capacity increase

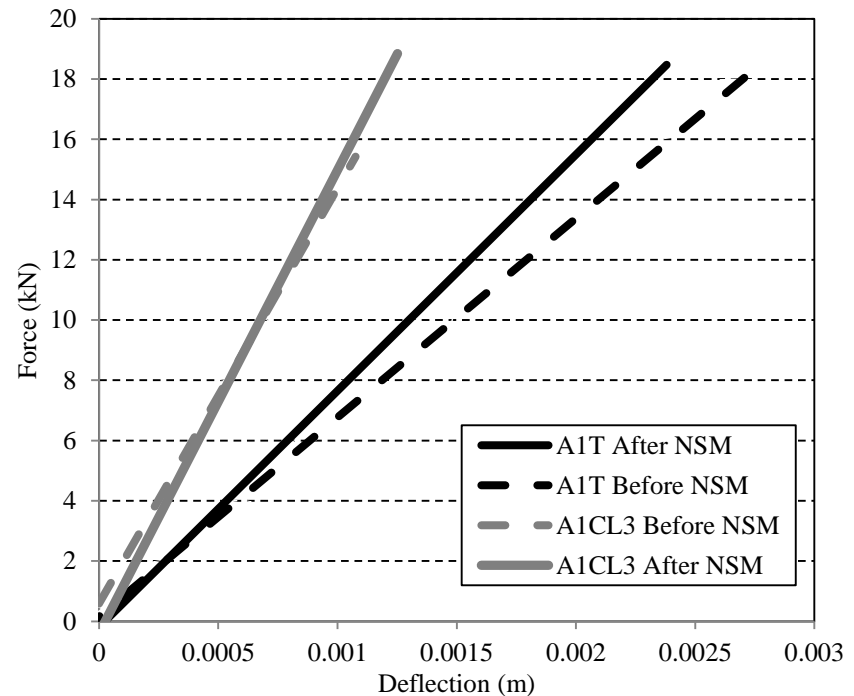
➔ NSM slightly increased the stiffness of RC beams

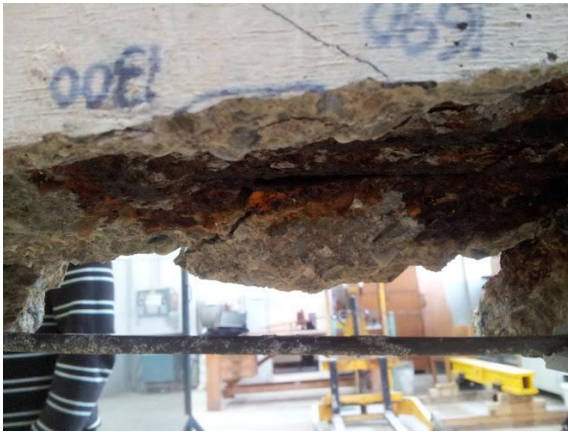
a) A1CL3-R Corroded Beam

➔ Failure of A1CL3-R occurred by the Separation of concrete cover.

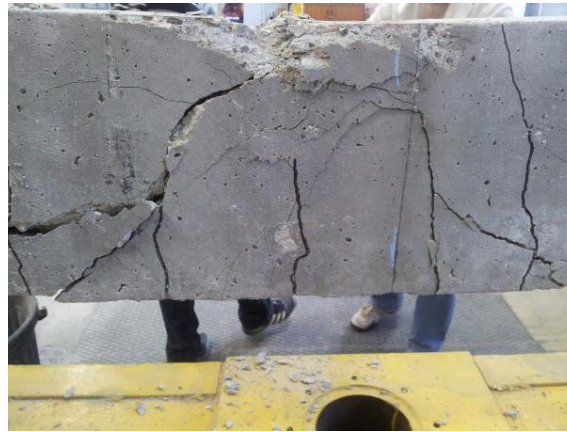
b) A1T-R Control Beam

➔ Failure of A1T-R was classical: yielding of the steel bars was reached, followed by crushing of the compressive concrete.

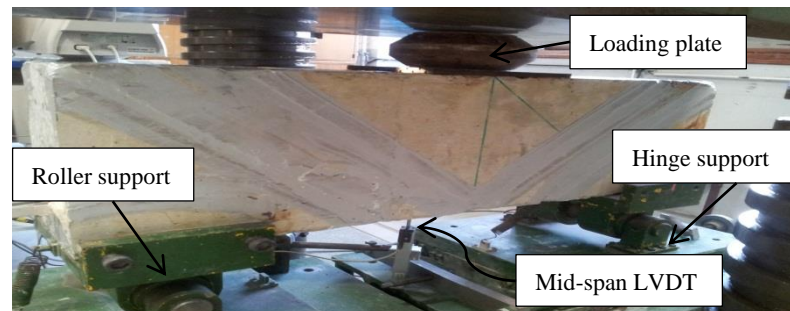
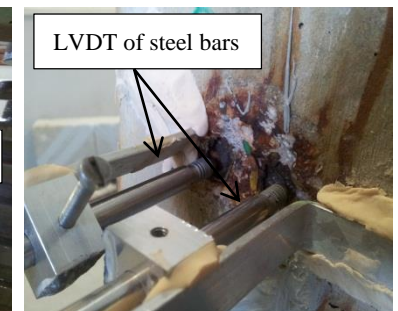
➔ Beam Instrumentation

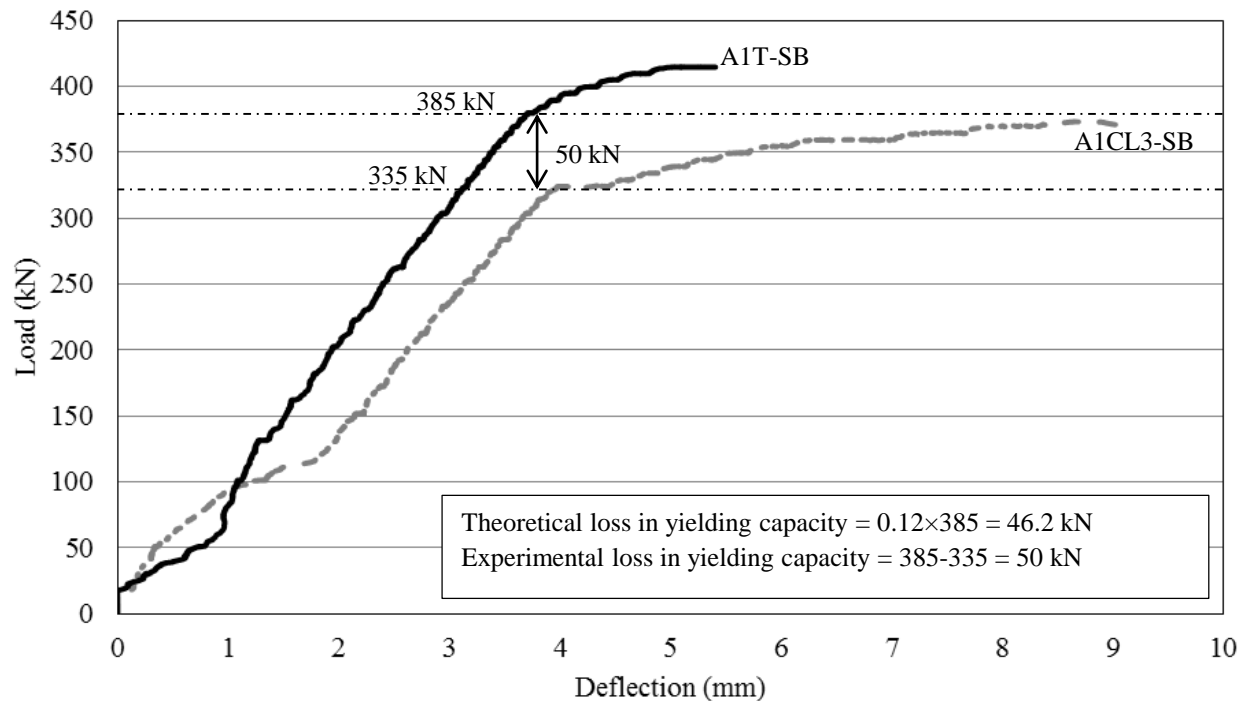
- ➔ Slip occurred in the non-corroded side of the beams.
- ➔ The diameter loss of longitudinal steel bars at the middle of the beam A1CL3-SB 6% meets 46.2 kN loss in the yielding capacity compared to A1T-SB

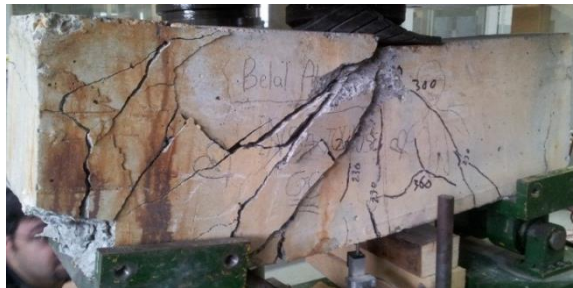
a. A1CL3-B

➔ Diagonal tension failure (Shear cracks failure with slip of tensile steel bars)

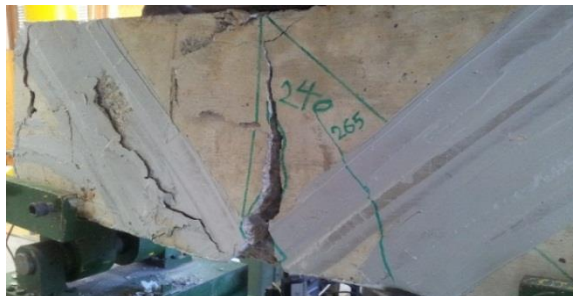
c. A1CL3-SB

➔ Compression crushing of the concrete (Large Flexural crack at the middle)

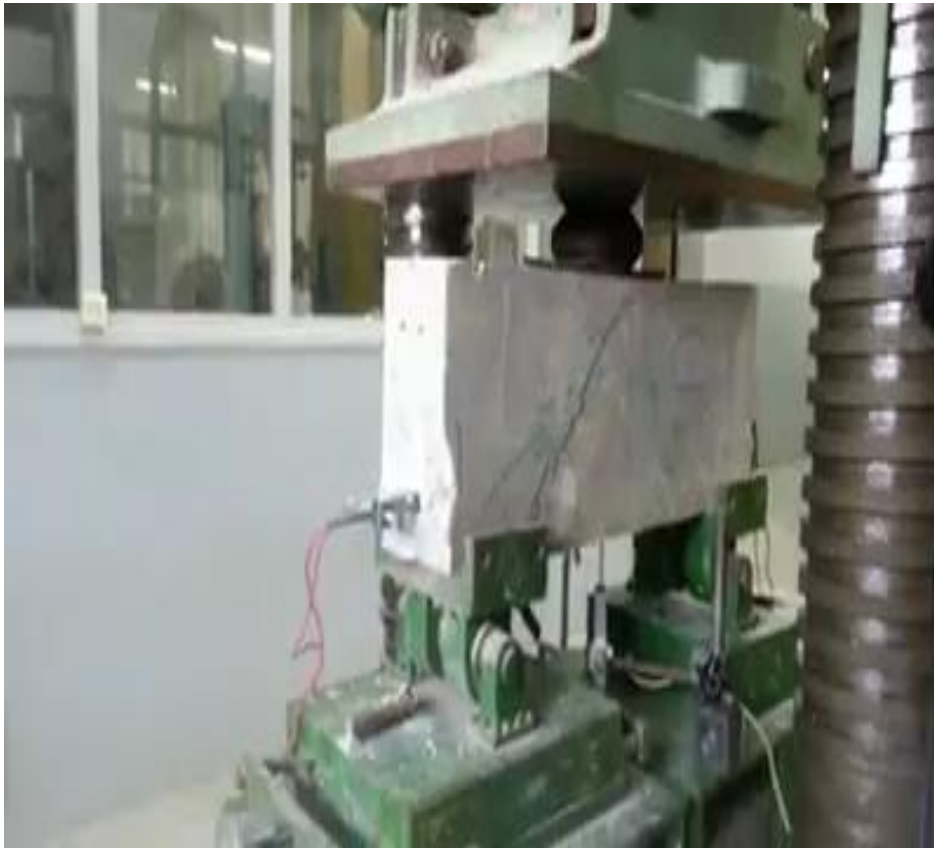
a. Diagonal Tension Failure

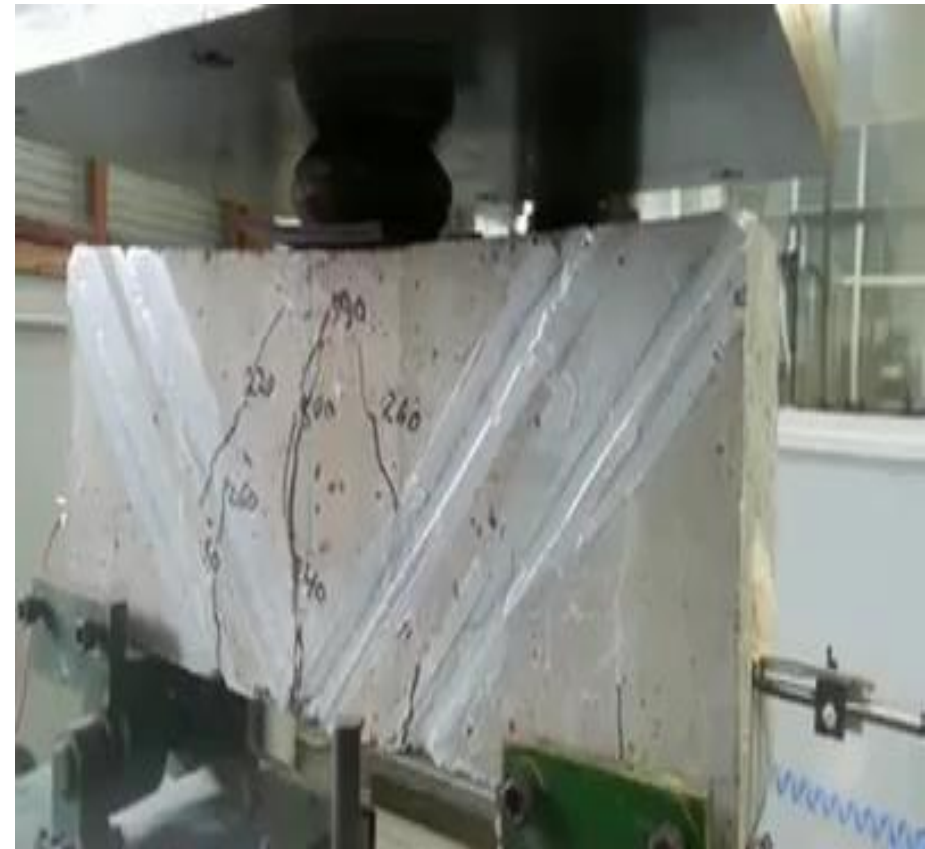
b. Concrete Crushing Failure

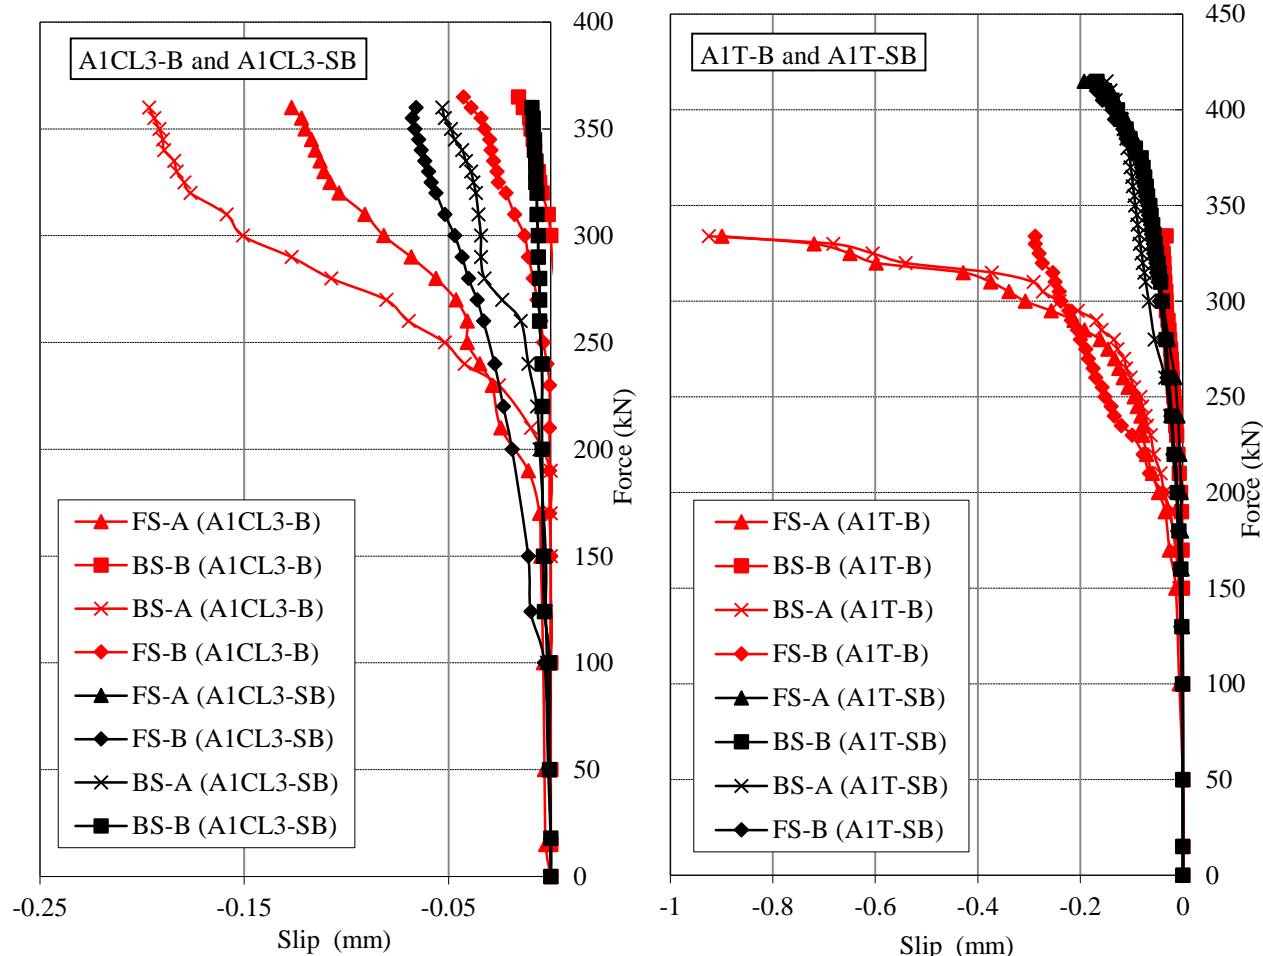
➔ The repairing in shear with NSM FRP rods decreased significantly the maximum slip values

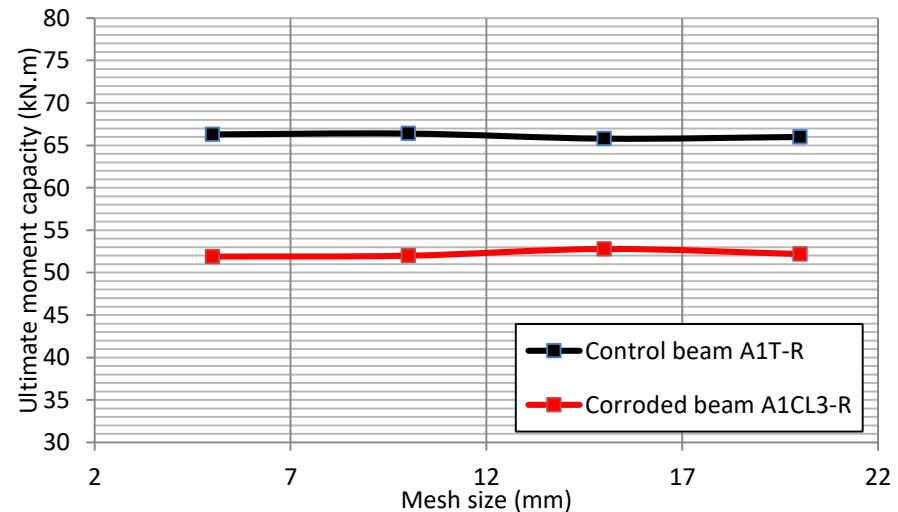
- ➔ There was no significant effect on the ultimate moment value for control beam A1T-R and corroded beam A1CL3-R if the mesh size is changed.
