Non-linear Pushover Analysis and simulation of progressive collapse mechanisms using FE Models for Nativity Church

Abstract. This paper presents some advanced finite element FE analyses conducted on one of the most historic structures in the world. The Church of Nativity located in Bethlehem (Palestine). To ensure the model quality, a 3D FE model was created using two different commercial software, DIANA FEA and SAP2000, one of the expected behaviors for this kind of masonry structure “low modal period” was found. The seismic behavior of the church was studied using pushover analyses, which were conducted using DIANA FEA as well as a dynamic analysis using SAP2000 is carried out using the accelerogram (1940 El Centro earthquake) to simulate a complete progressive collapse process. The first unidirectional mass proportional load pattern was created in both directions, X direction as a longitudinal direction and Y direction as the transversal direction. An incremental iterative procedure was used with monotonically increasing horizontal loads, using constant gravity loads. The results showed that the transversal direction is the most vulnerable and the damage concentrates at the mai

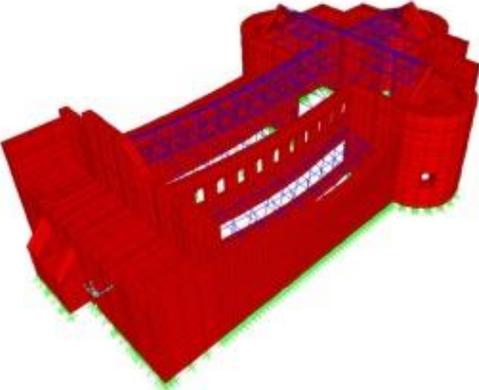
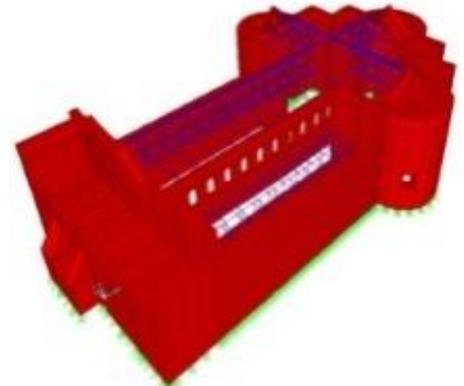
Table 3 Modal Analysis Using SAP 2000 and DIANA FEA

| SAP 2000 Model | DIANA FEA Model |
|---|--|
| <p>Mode (1) T=0.53 sec, F=1.89 Hz</p> | <p>Mode (1) T=0.55 sec, F=1.83 Hz</p> |
| <p>Mode (2) T=0.45 sec, F=2.22 Hz</p> | <p>Mode (2) T=0.41 sec, F=2.47 Hz</p> |

Mode (3) T=0.35 sec, F=2.86 Hz

Mode (4) T=0.29 sec, F=3.45 Hz

Mode (5) T=0.25 sec, F=4.00 Hz

Mode (6) T=0.24 sec, F=4.17 Hz

Mode (3) T=0.31 sec, F=3.20 Hz

Mode (4) T=0.27 sec, F=3.69 Hz

Mode (5) T=0.23 sec, F=4.32 Hz

Mode (6) T=0.23 sec, F=4.40 Hz

Mode (7) $T=0.20$ sec, $F=5.00$ Hz

Mode (7) $T=0.21$ sec, $F=4.74$ Hz

Mode (8) $T=0.18$ sec, $F=5.56$ Hz

Mode (8) $T=0.19$ sec, $F=5.27$ Hz

plane mechanisms. Table 3 shows the corresponding modal periods for the first 8 modes, generated from SAP 2000 and DIANA FEA and followed by a comparison between them for verification. In detail, the first, fourth, and sixth modes show the applicability of the interior walls to overturn and move in harmonically motion. In addition, out-of-plane mechanisms are possible also for the southern and northern walls, whose safety assessment would be necessary for local analysis, and can be confirmed in the second and third modes. As similar, the five and eight modes of the “as it is” model involves the translation motion in the two principal directions of church shoulders, these shoulders which have the properties of perimeter walls, play an important role in the connections between semi-circular apses, and finally, the seventh mode shows the overturning mechanism of façade, which undergoes larger displacement.
